## **Close Out Documents**

### **AP-77 – 4615 Fillmore St.**

Asbestos Abatement and Structural Demolition

**Structure Survey Assessment Report AP-77**

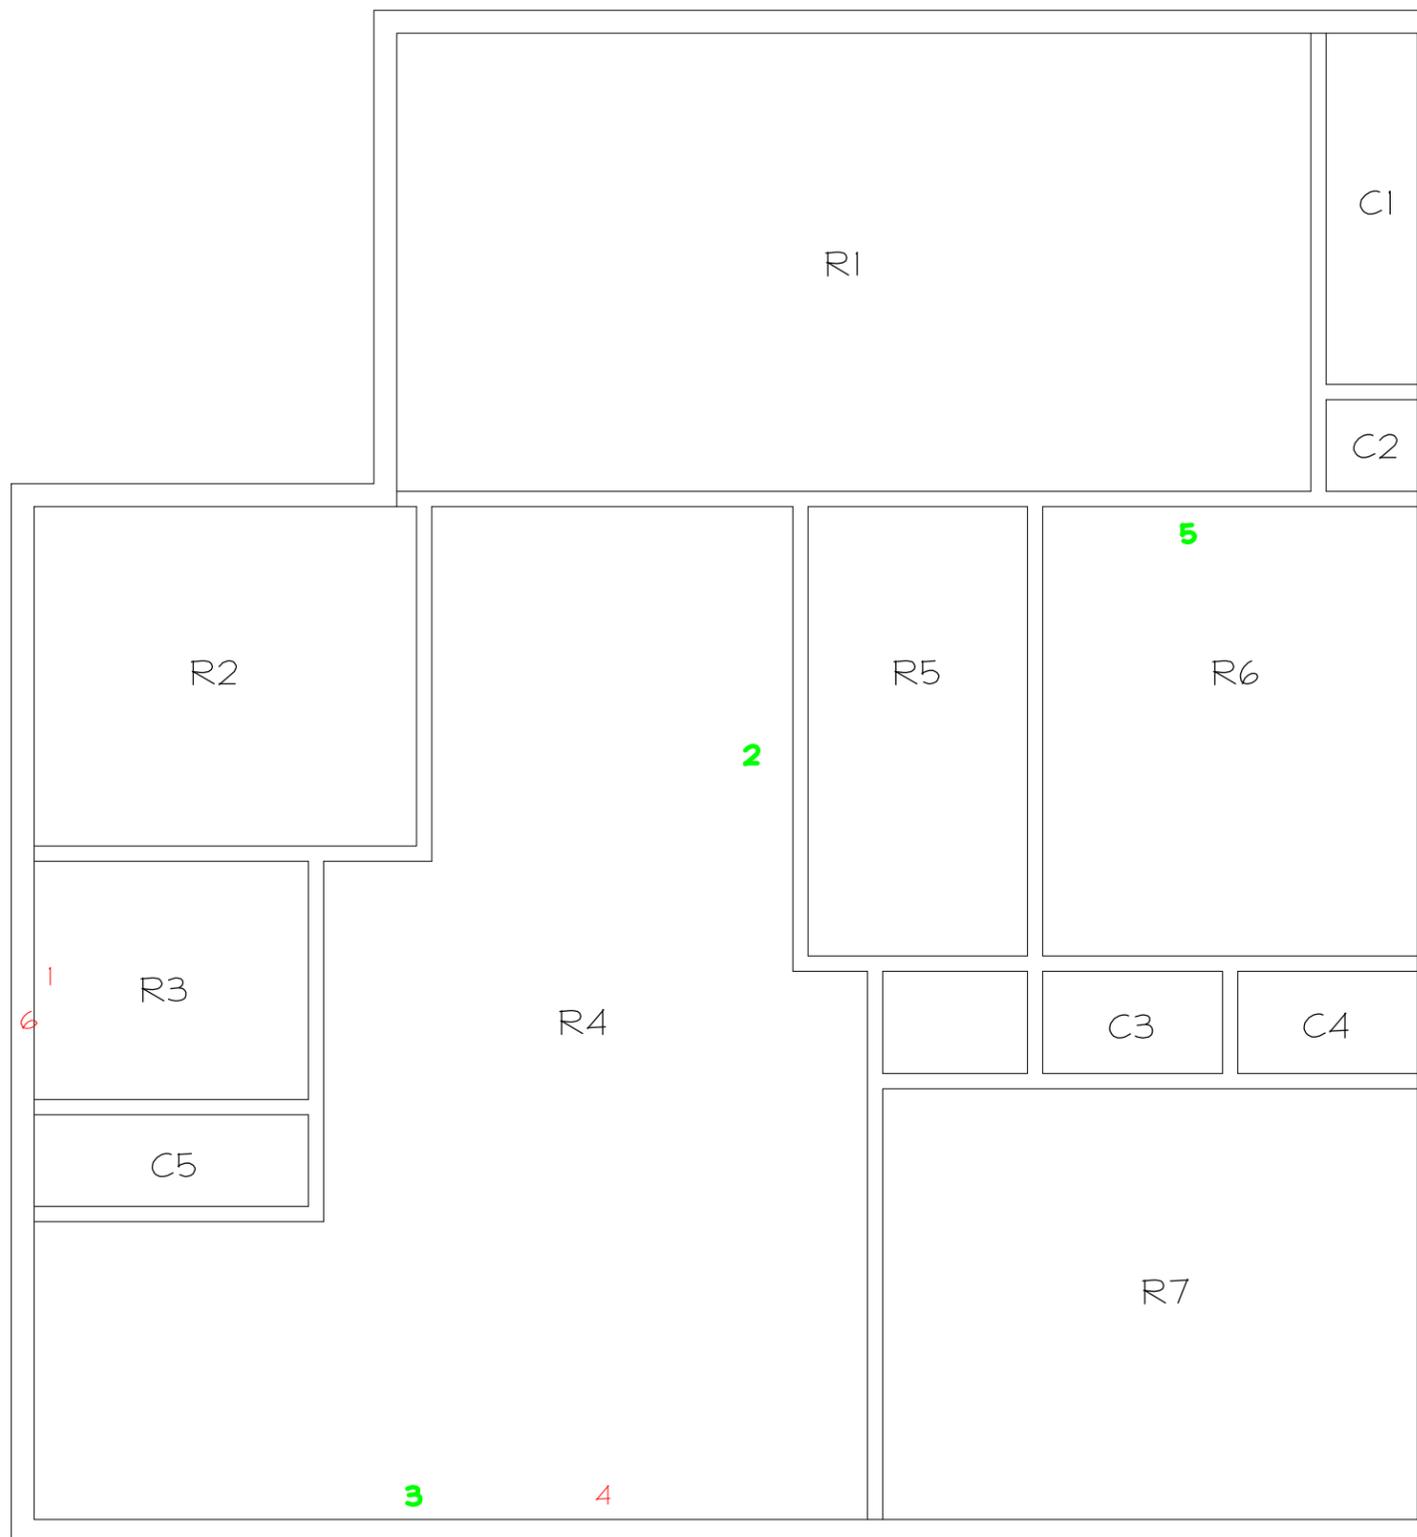
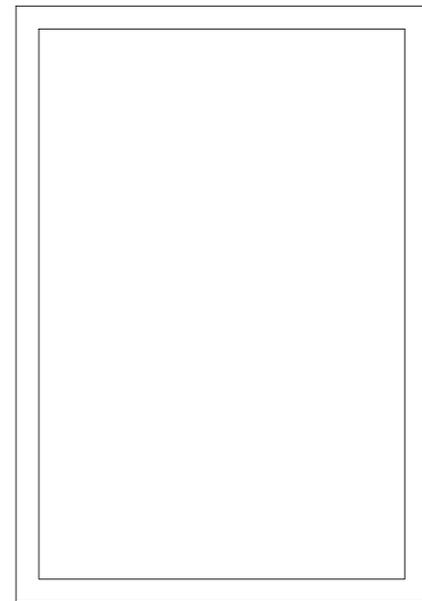
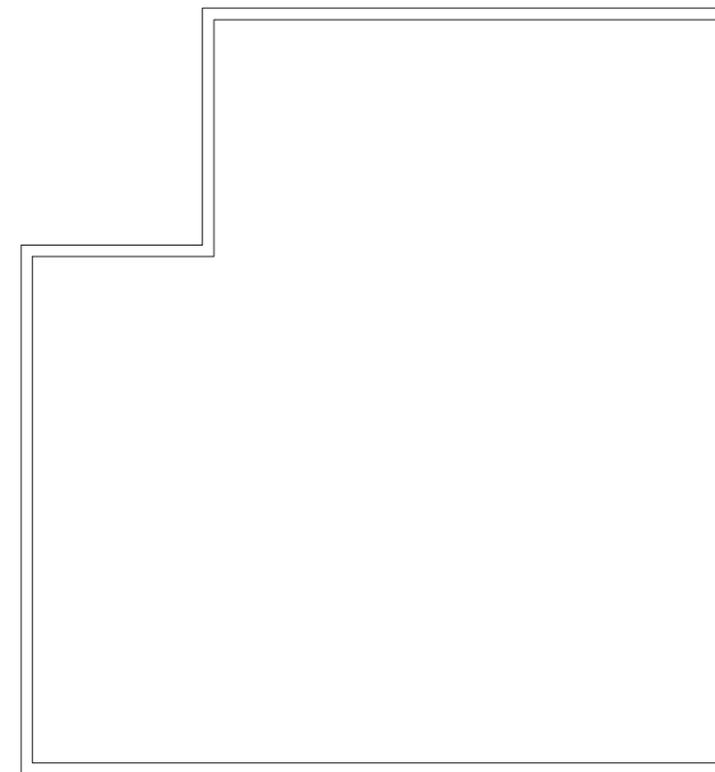
**FIGURE 3 - Lead Based Paint Sample Location**  
**CENTRAL 70 - Structure Survey Assessment Map**  
**AP-77**  
 4615 Fillmore St., Denver, CO  
 May 31, 2018  
 APEC #: 18-3066

One lead sample (4615F-R3-L-1) was found to be greater than 0.06% by weight and less than 0.5% by weight and is considered LCP. Four samples (4615F-R3-L-4, 4615F-R6-L-6, 4615F-EX-L-7, 4615F-EX-L-8) were found to be greater than 0.5% by weight and are considered LBP (Table 3-2). The remaining 3 samples were less than the LCP and LBP thresholds, and are considered NLC. The laboratory analytical report is included in Appendix D.

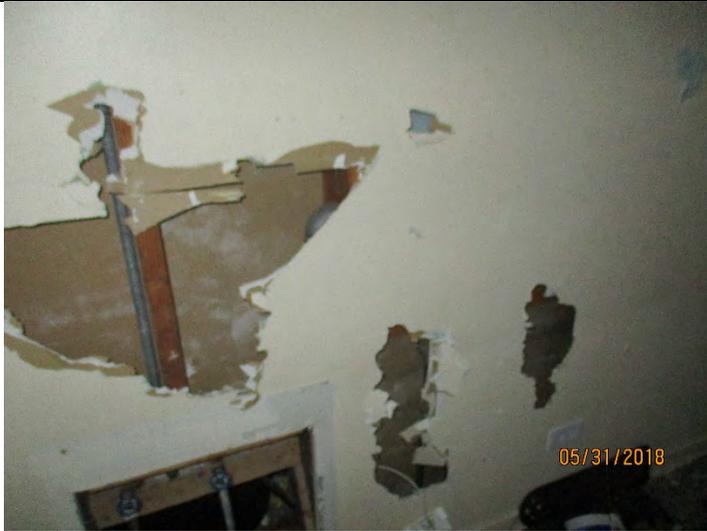
Heavy Textured Composite Board

Samples Represented –  
AP53-R6-TC1A  
AP53-R6-TC1B  
AP53-R5-TC1C  
AP53-R4-TC1D  
AP53-R4-TC1E

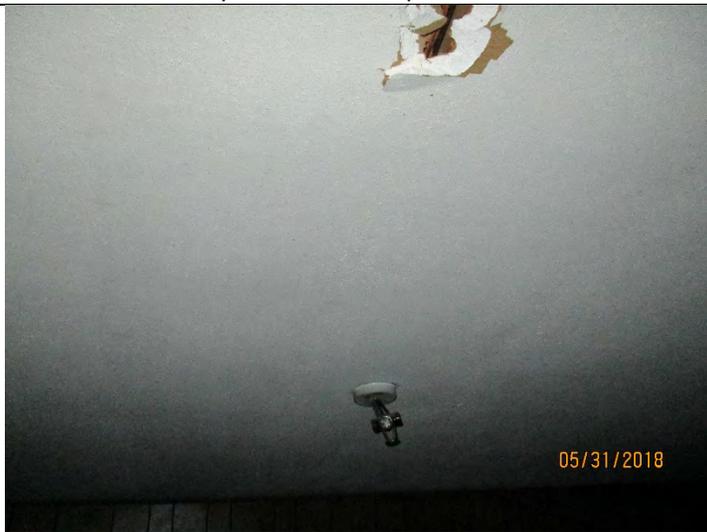
Swirl Textured Composite Board

Samples Represented –  
AP53-R6-TC3A  
AP53-R5-TC3B  
AP53-R4-TC3C

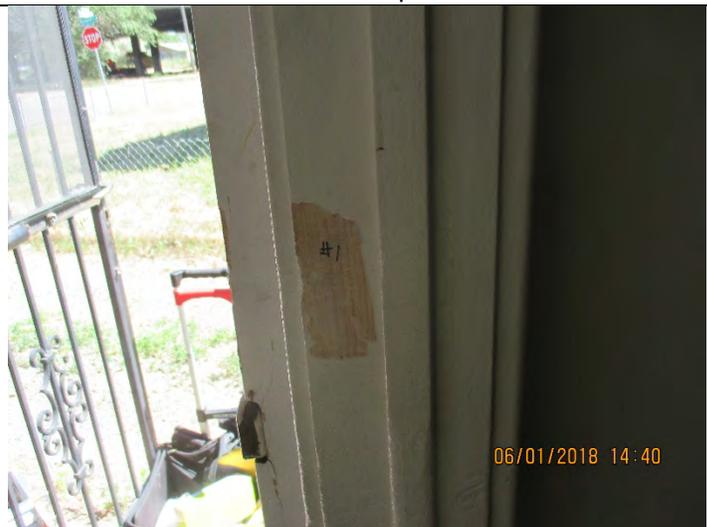
White - LCP

Samples Represented –  
4615-R3-L-1

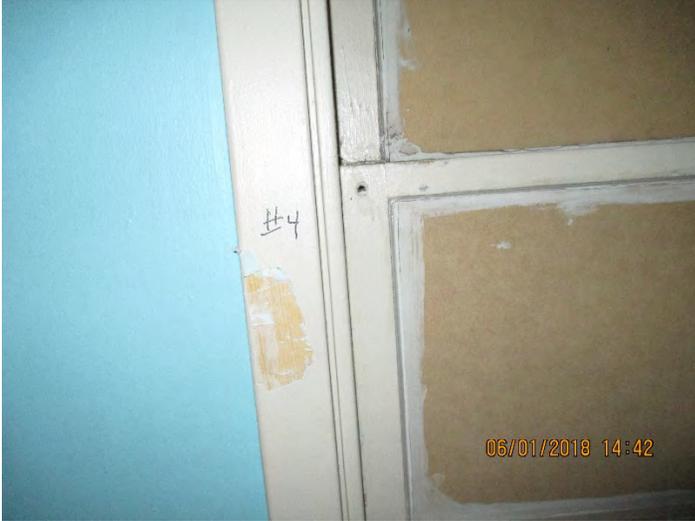
Off-White - LBP

Sample Represented –  
4615-R4-L-4

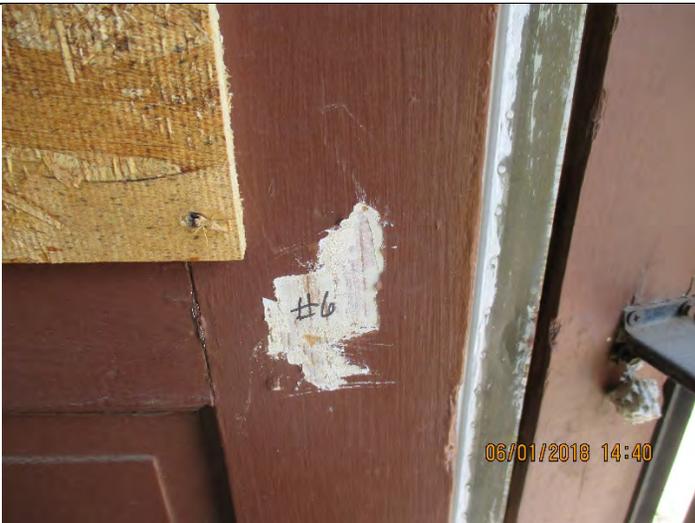
Brown - LBP

Sample Represented –  
4615-R6-L-6

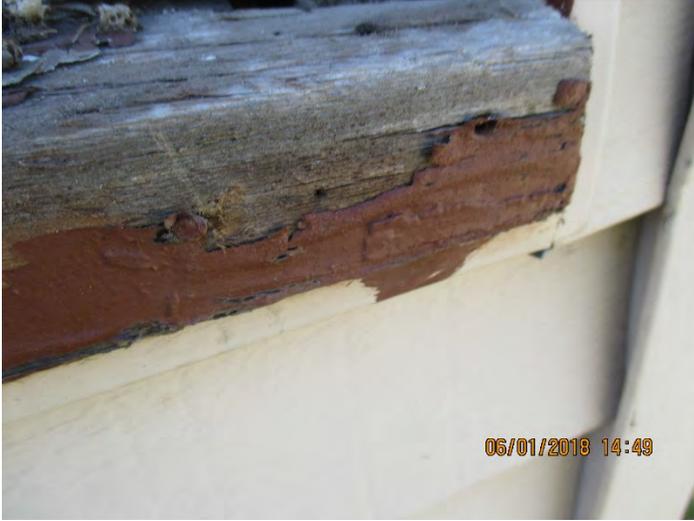
Brown - LBP

Sample Represented –  
4615-Ex-L-8
